Frontiers in Built Environment

Lessons Learnt From the 2009 Padang Indonesia, 2011 Tōhoku Japan and 2016 Muisne Ecuador Earthquakes

Keywords: earthquakes, Padang, Tōhoku, Muisne, buildings, foundations, landslides, geospatial tools

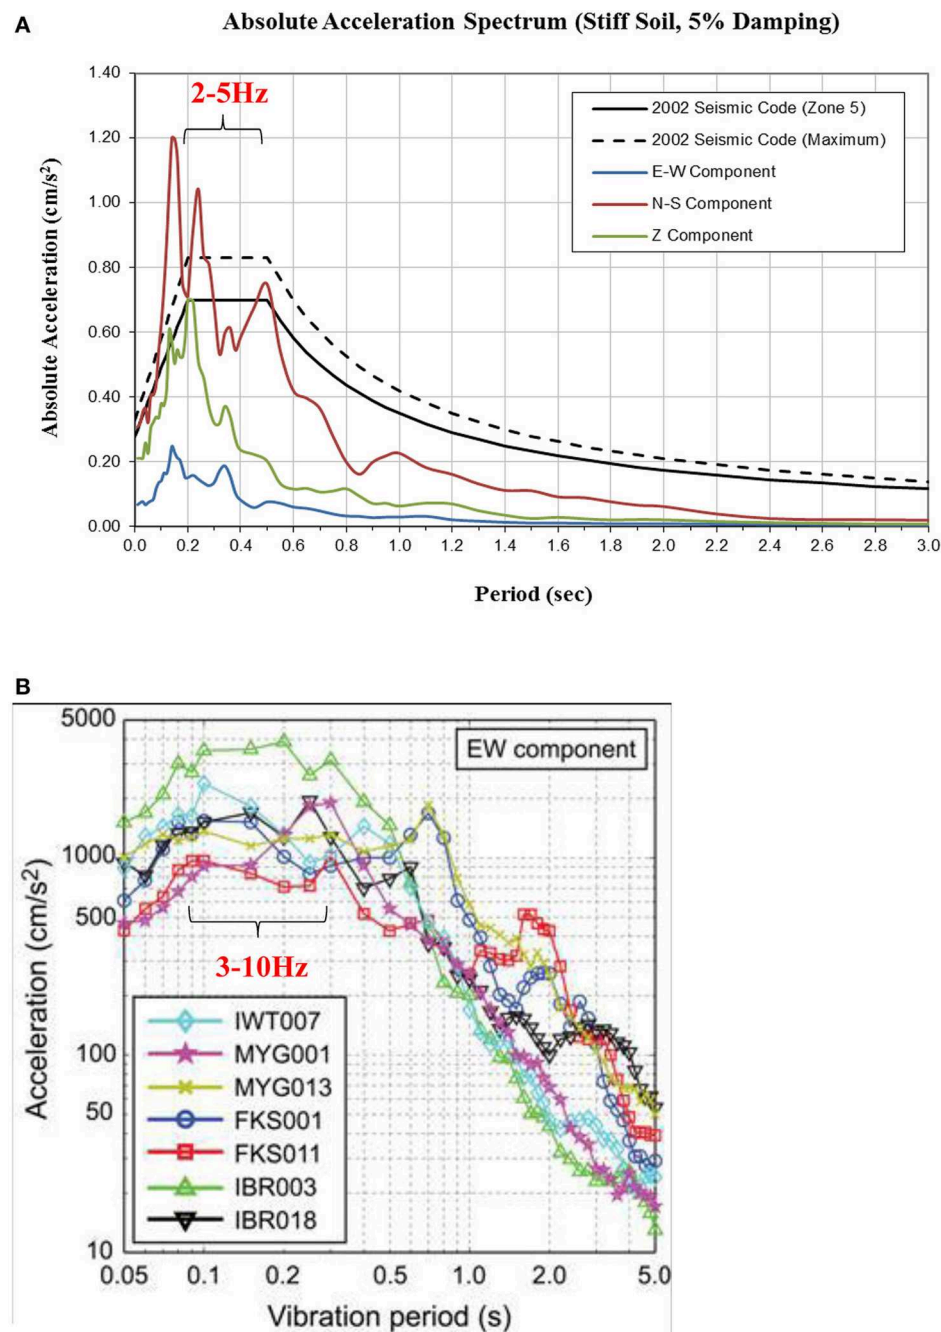
Based on the synthetic earthquake time history in **Figure 5A**, dominant frequencies were between 2 and 5 Hz. This range of frequencies are more likely to affect two- to five- stories building with coinciding natural frequencies, which were in agreement with observations that RC buildings six stories and above did not suffer significant structural damage, including one with glass façade. In contrast, schools were usually simple one-story masonry structures with timber and corrugated steel roofs. They performed particularly badly with 2,164 severely damaged or experienced collapse [Badan Nasional Penanggulangan Bencana (BNPB), 2009]. Industrial and port facilities performed extremely well and only suffered minor structural damage. There were examples of buildings that experienced strong ground shaking as evident by the major damage to masonry infill, but suffered only minimal structural damage. This suggests that the latest Indonesian earthquake code, its design practice and construction, is seismically sufficient for an earthquake of this intensity. The first Indonesian national building code (PPIUG) was developed in 1983 (Direktorat Penyelidikan Masalah Bangunan, 1983). It was adapted from the New Zealand seismic standard which applied uniform hazard concept with 200 years design earthquake return period. This Indonesian code had been revised several times since then, however, it is only since 2002 that

FIGURE 5 | Response spectra of Padang and Tohoku earthquakes. **(A)** 2009 Padang earthquake response spectra vs. uniform hazard response spectra of Indonesian seismic code [Earthquake Engineering Field Investigation Team (EEFIT), 2009]. **(B)** Elastic response spectra of the recorded mainshock ground motions, East-West component at the seven K-NET station [Earthquake Engineering Field Investigation Team (EEFIT), 2011].

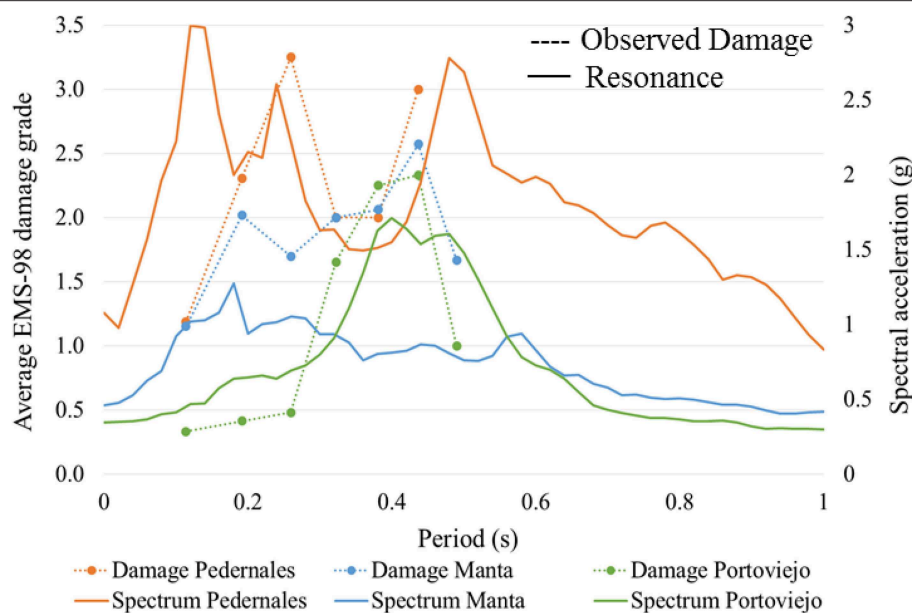
Figure 10 compares the spectral accelerations recorded at stations in Pedernales, Manta, and Portoviejo, with the average damage grades of RC and timber/bamboo structures of different fundamental periods estimated based on their typology and height. It can be observed that higher grades of damage generally coincide with higher spectral acceleration of the shaking in

Pedernales, Manta and Portoviejo at similar periods. This confirms damage attributed to structural resonance which is in line with findings in Padang and Tōhoku earthquakes. Significant damage was observed for two- to five-story buildings at Pedernales which coincides with the dominant periods of 0.2 and 0.5 s. Similarly, two- to four-stories were observed to be most heavily damaged at Manta and Portoviejo, respectively which coincides with young Quaternary sediments according to the geological map in **Figure 3B**. In contrast, high-rise buildings >10 stories were most affected at Chone where dominant shaking period was 1.3 s. It is worth noting that earlier versions of the seismic code in Ecuador (e.g., Código de Práctica Ecuatoriano, 2001; CPE INEN 5:2001) were based on US seismic codes of the time (e.g., Uniform Building Code, 1997). The latest version has been updated in recent years (Norma Ecuatoriana de la Construcción, 2015), maintaining however the manner in which seismic actions are derived. Microtremor recording using a TROMINO Zero[®] instrument, non-invasive, passive geophysical method, was conducted at several locations in Manta, Portoviejo, Pedernales, and Bahia to ascertain the fundamental frequency and shear wave velocity profiles for each site for site response analysis. The method is based on measuring ambient seismic noise and translating it through time domain

FIGURE 10 | Relationship between response spectra from recorded ground motions and surveyed building damaged (Franco et al., 2017).

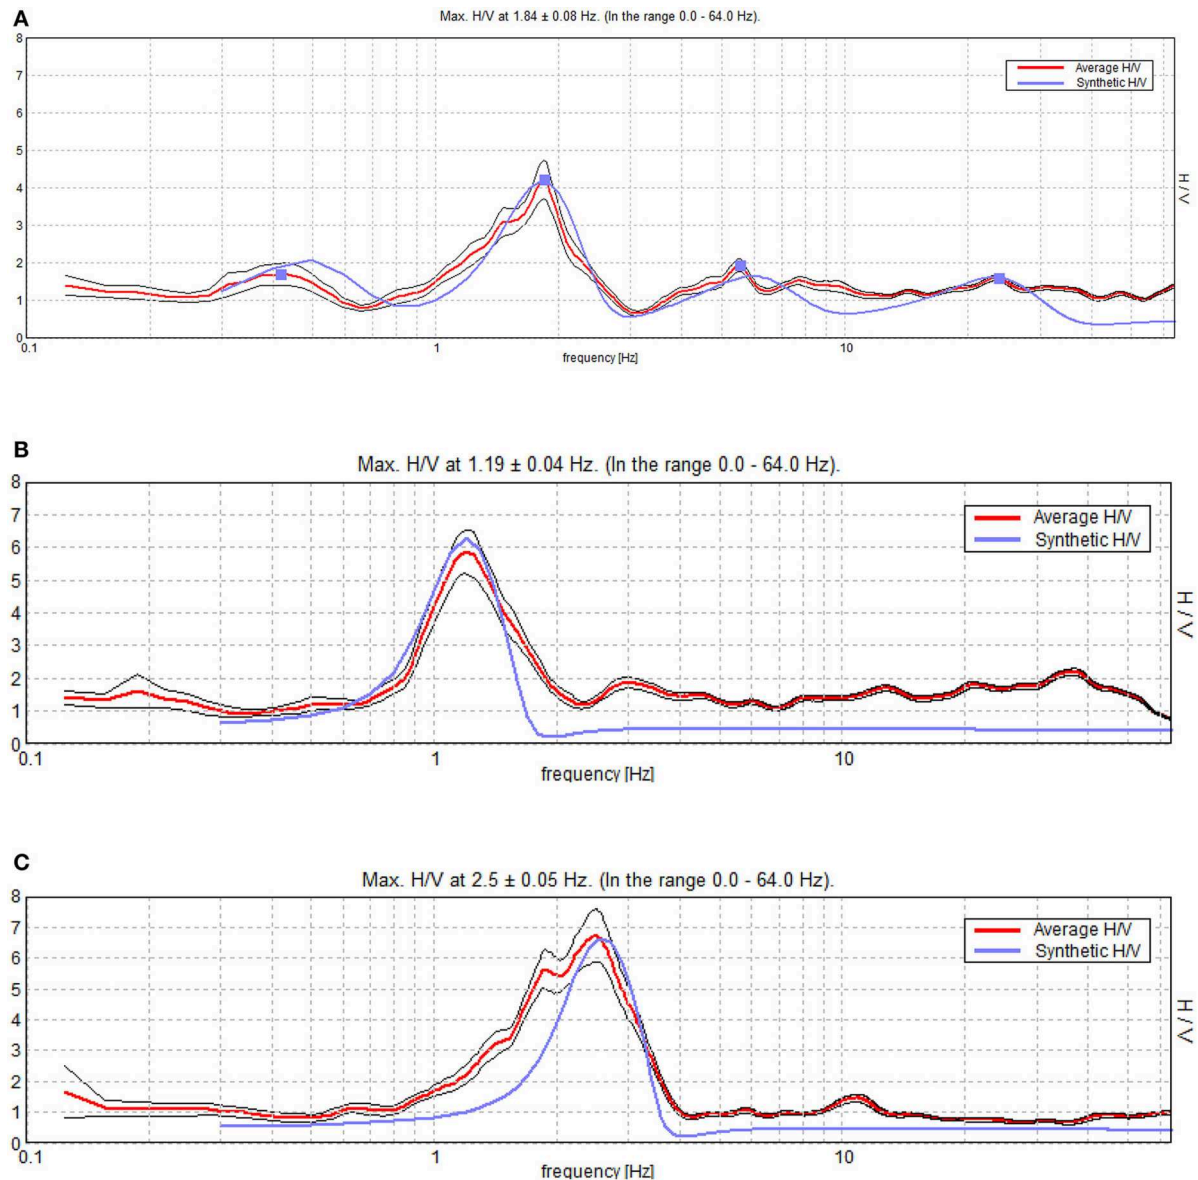
and spectral techniques (Nakamura, 1989). Measurements were taken close to the locations of strong ground recording stations installed by the Instituto Geofísico in Pedernales and Portoviejo. **Figure 11** shows the comparison of the H/V ratio measurement and shear wave velocity profile at Manta, Portoviejo and Pedernales. Further details of the microtremor analysis can be found in the reconnaissance report [Earthquake Engineering Field Investigation Team (EEFIT), 2016].

FIGURE 11 | H/V ratio measurements and derived spectrum from *in situ* shear wave velocity at various sites in Ecuador. **(A)** Tarqui, Manta. **(B)** River Bank, Portoviejo. **(C)** Seismic measuring station APED, Pedernales.
